**DEPARTMENT OF TRANSPORTATION****DIVISION OF ENGINEERING SERVICES**

Office of Structural Materials

Quality Assurance and Source Inspection

Contract #: 04-0120F4Cty: SF/ALA Rte: 80 PM: 13.2/13.9File #: 69.15**SOURCE INSPECTION REPORT****Resident Engineer:** Pursell, Gary**Address:** 333 Burma Road**City:** Oakland, CA 94607**Report No:** SIR-002510**Date Inspected:** 14-Jul-2010**Project Name:** SAS Superstructure**OSM Arrival Time:** 700**Prime Contractor:** American Bridge/Fluor Enterprises, a JV**OSM Departure Time:** 1700**Contractor:** Zhenhua Port Machinery Company, Ltd (ZPMC), Changxing Island **Location:** Shanghai, China**Quality Control Contact:** Mr. Don Walton**Quality Control Present:** Yes No**Material transfer:** Yes No N/A**Sampled Items:** Yes No N/A**Stock Transfer:** Yes No N/A**OK to Cut:** Yes No N/A**Rebar Test Witness:** Yes No N/A**Delayed/Cancelled:** Yes No N/A**Other:** Coating Inspection**Bridge No:** 34-0006**Component:** See Below**Bid Item:** 77, 78, 79**Lot No:** B #204**Summary of Items Observed:**

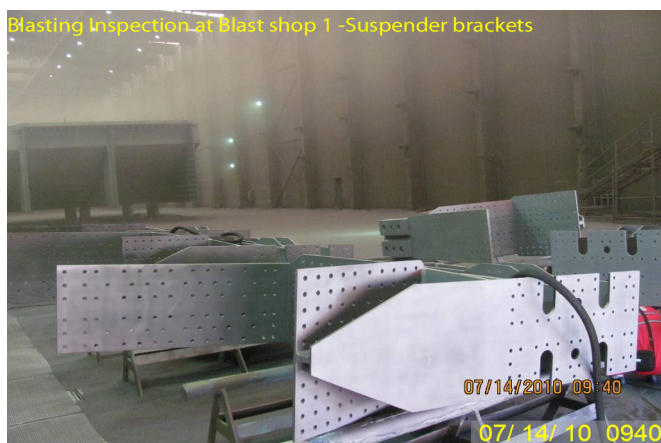
1. An inspection was requested on the OBG Counter weight External surface - 12 sets and Suspender brackets external surface - 12 sets, for DFT check and final acceptance, vide request no. 3678 at Painting workshop 2. Caltrans Engineer Mr. Aaron Prichlik have been informed and after inspecting the surface He accepted 12 sets of counter weights. Counter weight CB- 56 , This Caltrans Inspector observed some pin holes in the bottom plate, which was attended by ZPMC Personnels. This Caltrans inspector Baskar Govindarajan observed ABF inspector Mr Sun and Mr. Wei assisting this inspection by carrying out DFT readings. Mr. Aaron prichlik rejected 12 sets of suspender brackets for high DFT which is in the range of 350 to 600 which is not acceptable as per contract documents. International protective coatings technical service representative Mr. Lou Qian Chuan was found present during the course of this inspection process. Photograph showing suspender brackets in finish paint condition is attached with this report.

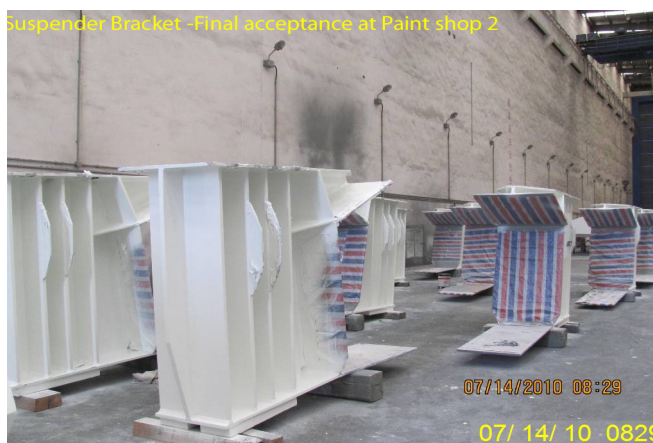
2. An inspection was requested for the OBG Suspender Bracket -4 sets (SB 48E, 48W, 54W, 60 E) and Reblasting of suspender brackets -2 sets (SB 52 W, SB 56E) vide inspection request no. 3682 for Interzinc 22 application and Residual chlorides test. This Caltrans inspector observed, ABF inspector Mr. Wei and Mr. Hong Cai Yan performing the Blasting inspection. The profile measured by ZPMC QC Inspectors found to be in the range of 78 to 86 microns. Residual chlorides test conducted at 1 place and the result found to be 20 us/cm. The profile range

and salt test result found to be acceptable as per contract Documents. Minor Blasting mistakes pointed out by ABF Inspectors which was found attended by ZPMC Personnels. International protective coating representative Mr. Lou Qian Chuan was found present during the inspection process. (Photo attached)
